Harness Structural test Report

Inspection certificate number: **PH_255.2018**

Name: **Alpamayo**
 Type: **ABS**
 Size: **unique size**
 Serial number: **23469**
 Impact pad type: ⁽¹⁾ **n/a**
 Clip-in weight [kg]: **120**

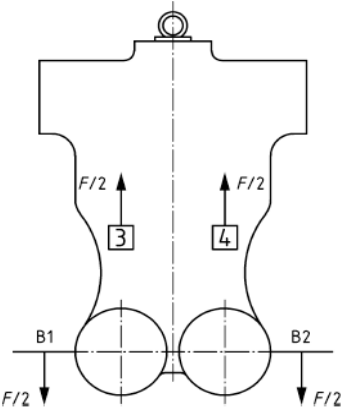
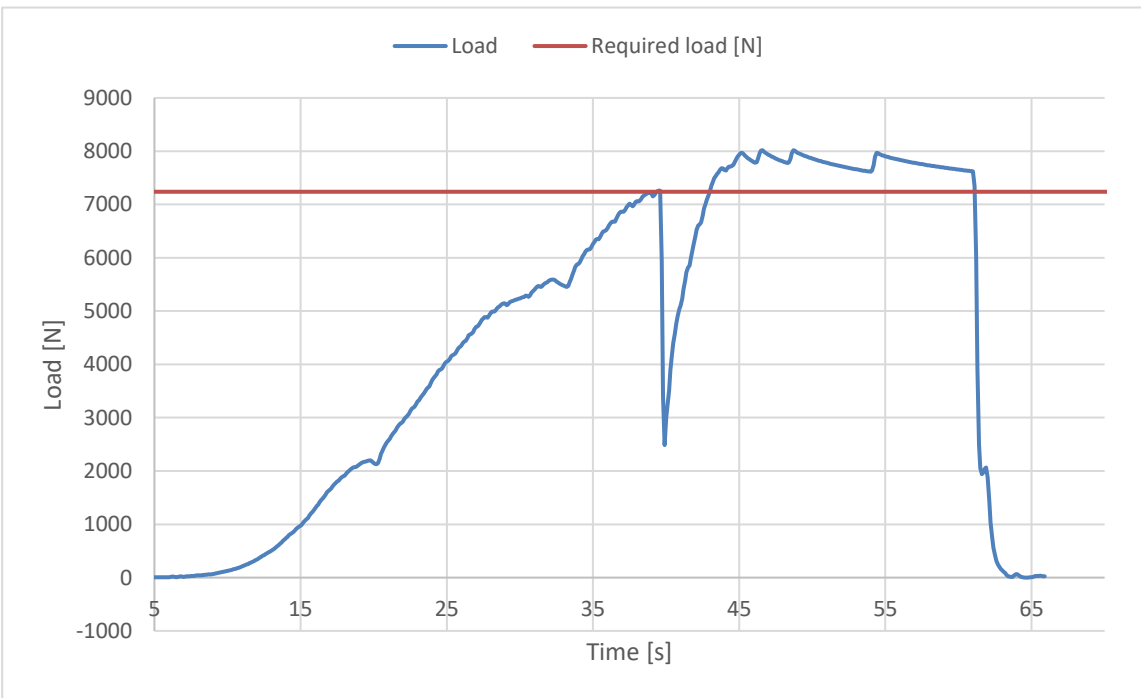
Test ID R0

| Any signs of structural failure | No | |
| Test results | POSITIVE | |

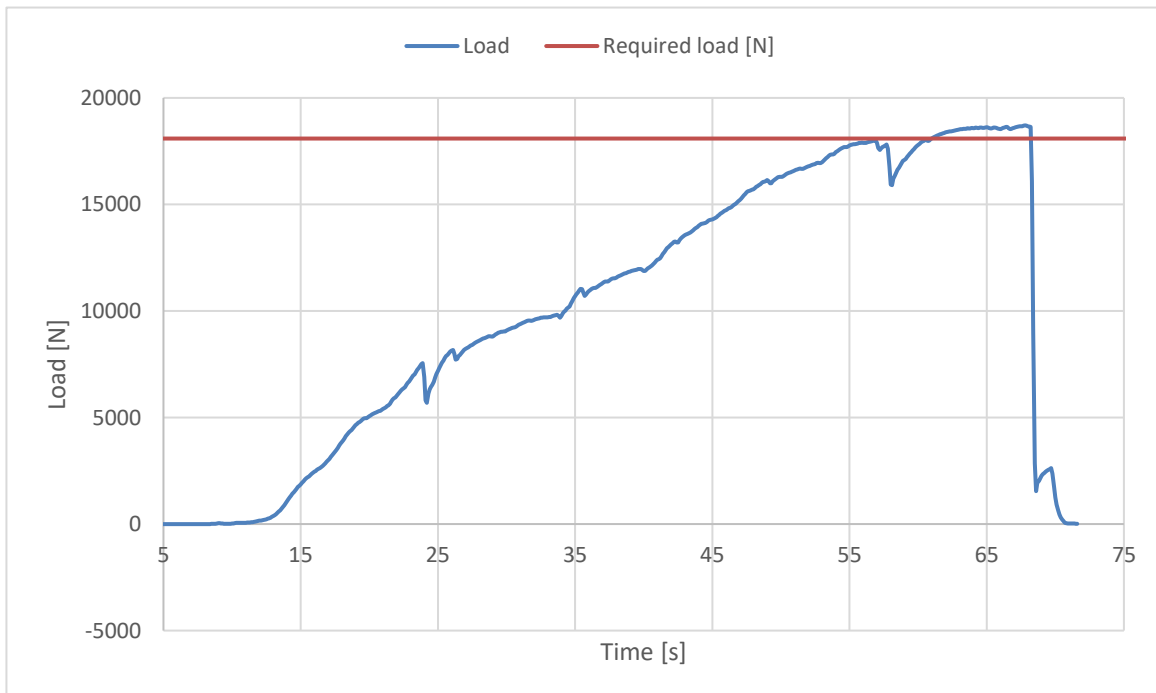
Test ID R2

| Any signs of structural failure | No | |
| Test results | POSITIVE | |

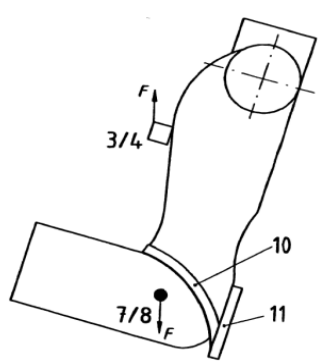
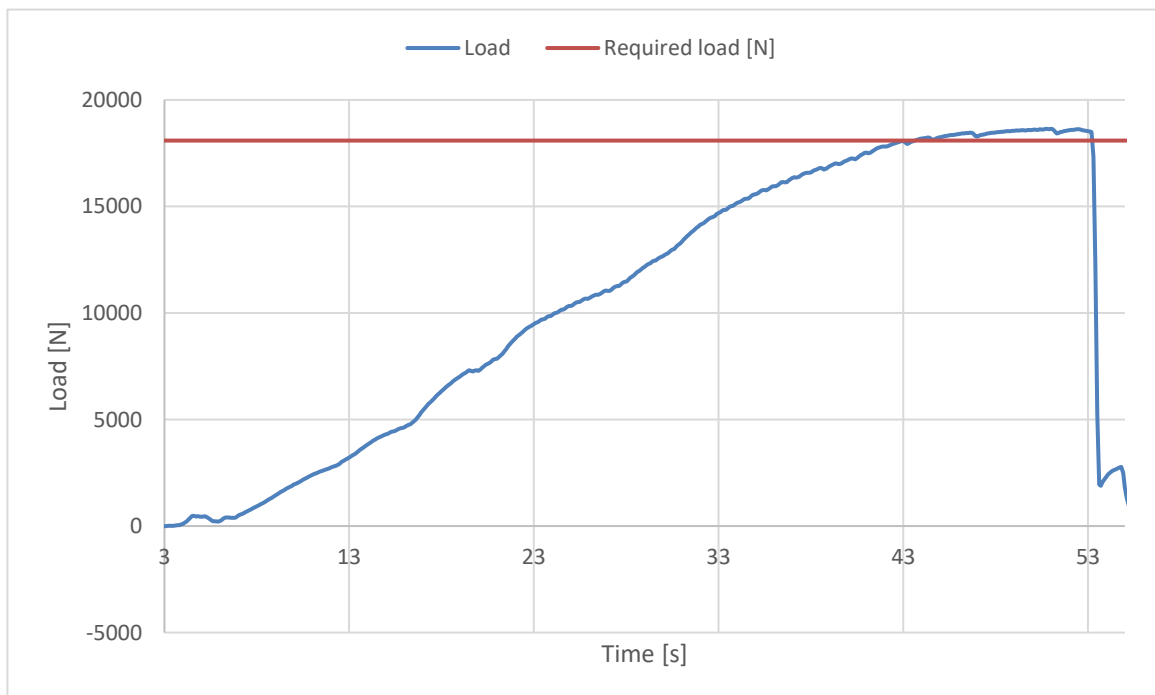
Test ID R4

| Any signs of structural failure | No |
| Test results | POSITIVE |

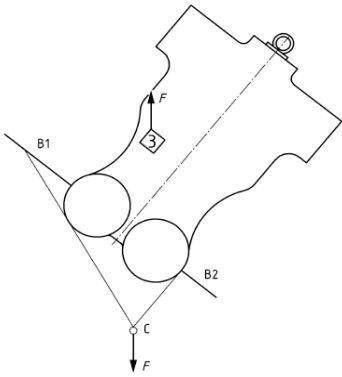
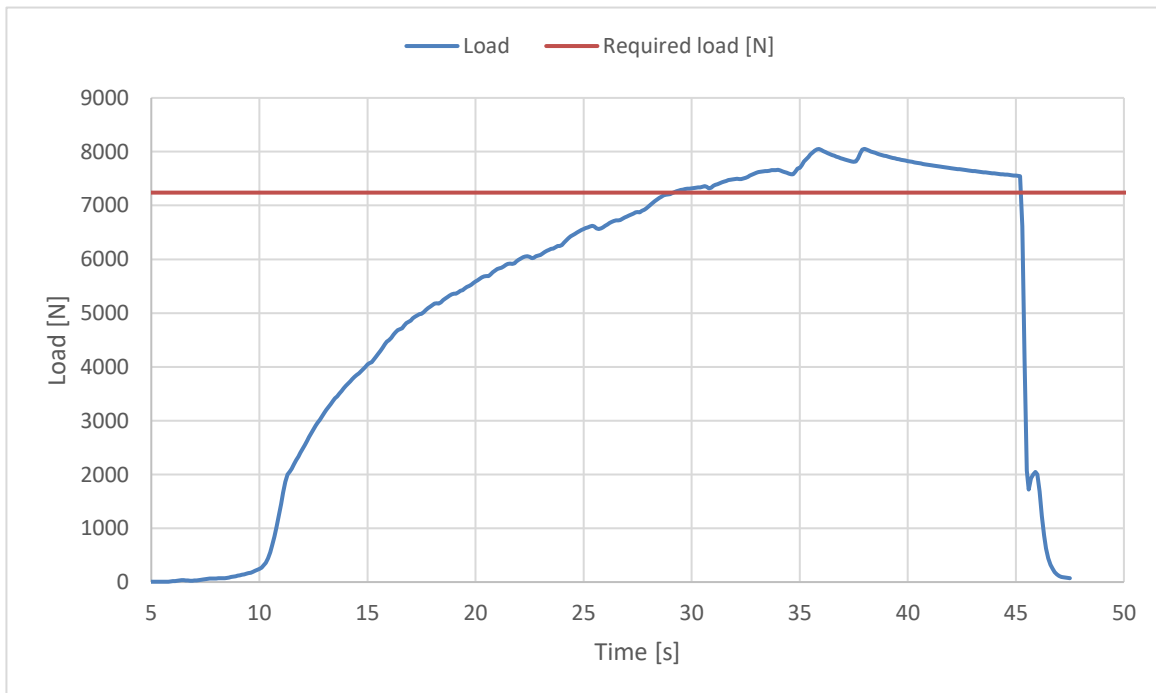
Test ID R8

| Any signs of structural failure | No |
| Test results | POSITIVE |

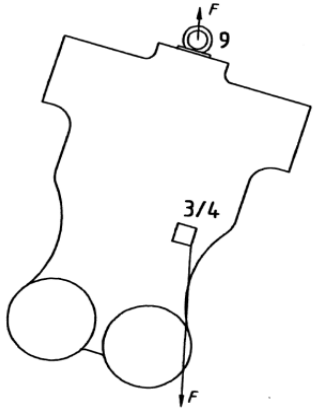
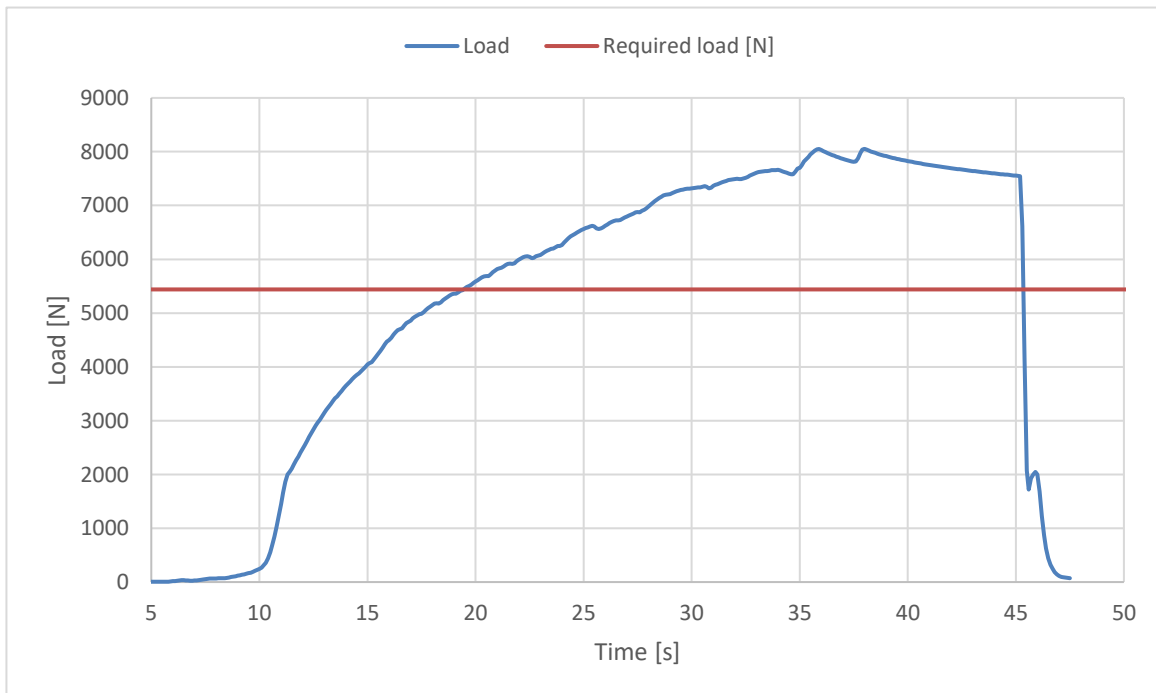
Test ID R10

| Any signs of structural failure | No | |
| Test results | POSITIVE | |
